Monitoring Series No. ME-09-MSTY-0797-1

THREE-YEAR COMPREHENSIVE MONITORING REPORT

**CAMERON PRAIRIE REFUGE PROTECTION  
ME-09**

**First Priority List Shoreline Protection Project  
of the Coastal Wetlands Planning, Protection, and Restoration Act  
(Public Law 101-646)**

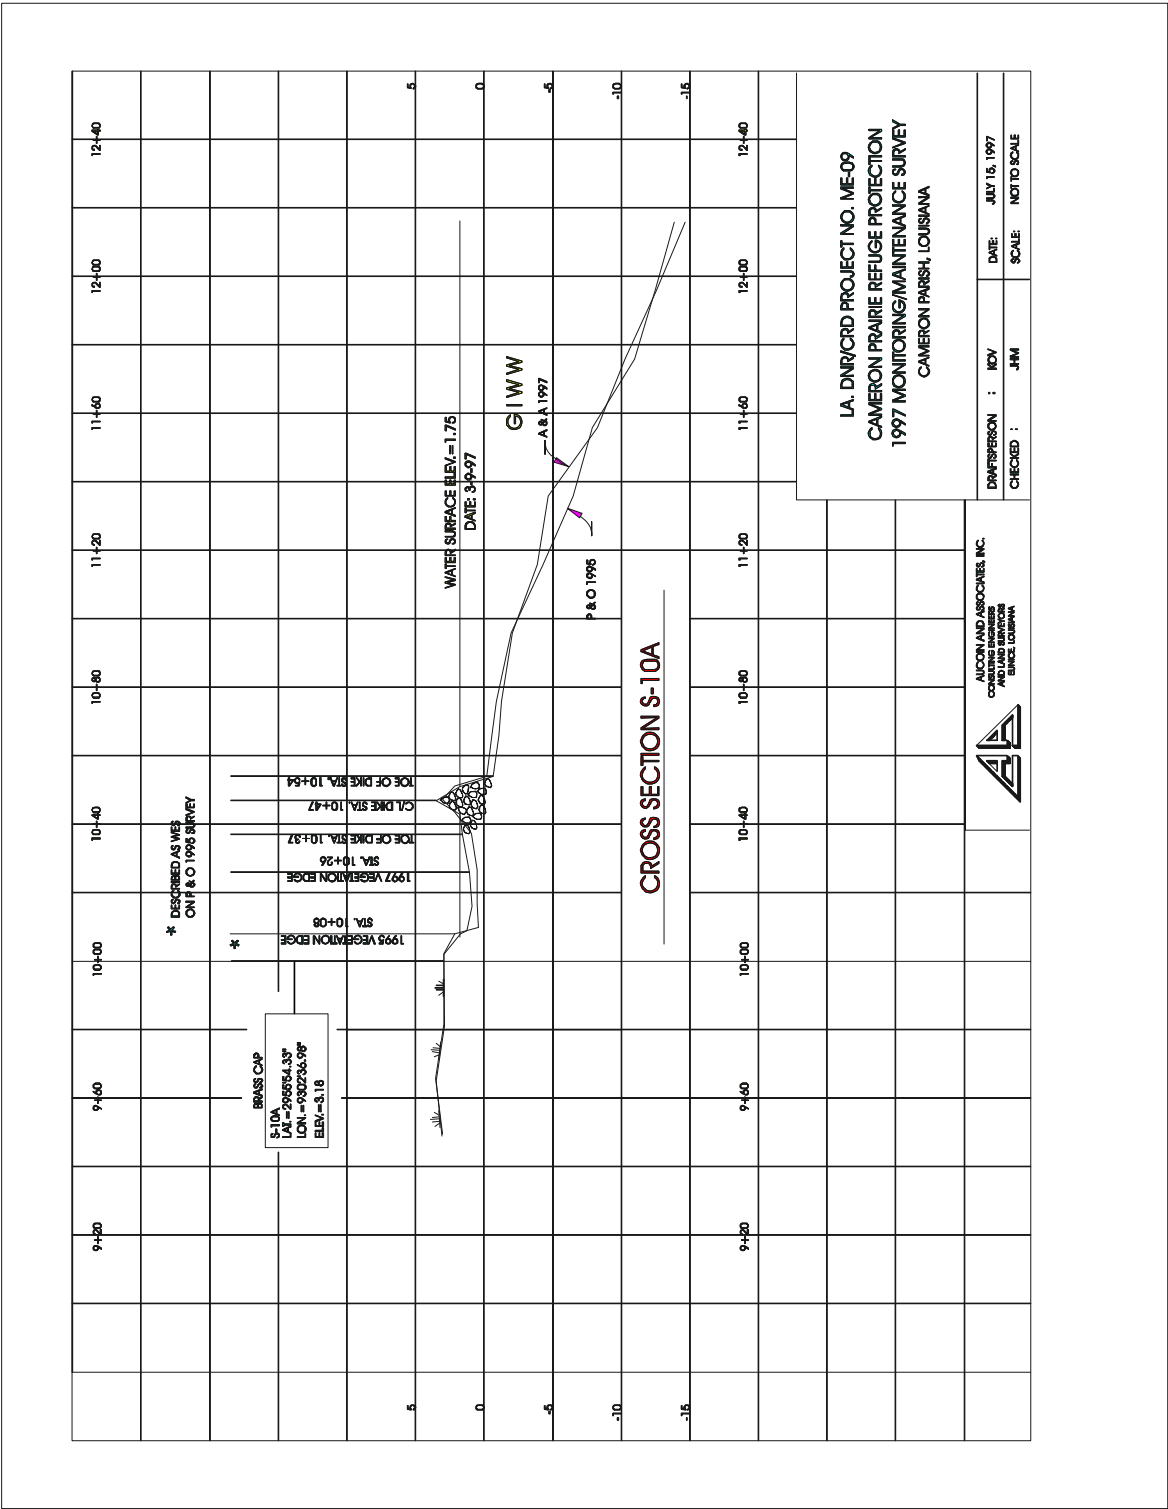
**Figure 13.** Cameron Prairie Refuge Protection (ME-09) cross section S-10A in the project area showing the survey lines, vegetation edge, and channel profile.

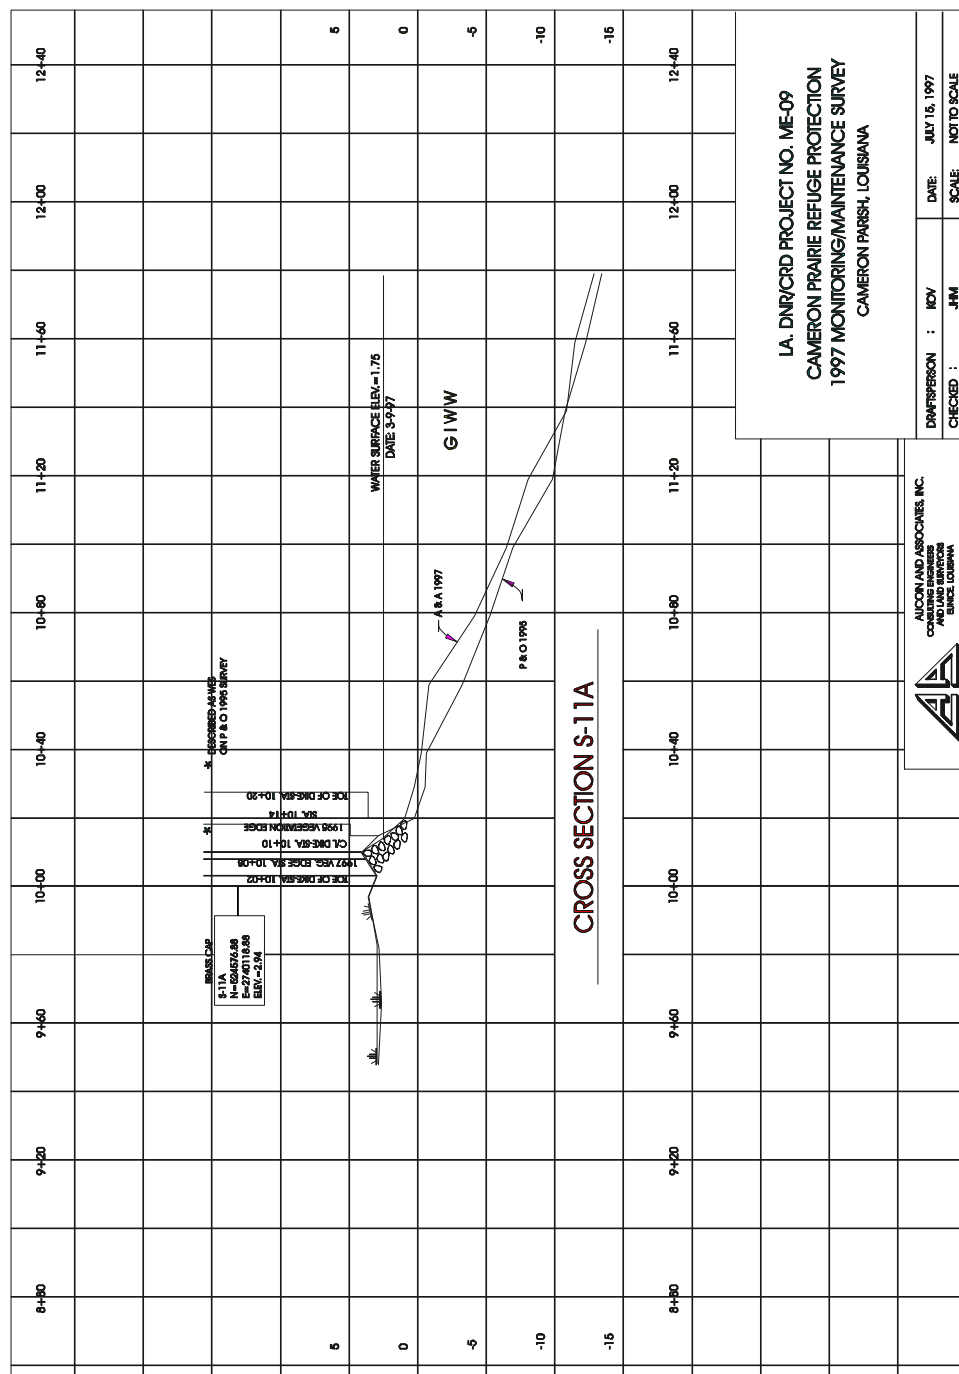
Erosion was indicated at only one station in the project area at station S-11A (figure 14). Apparently, the 1995 surveyors interpreted the vegetated edge to be on the GIWW side of the rock dike while the 1997 surveyors interpreted the vegetated edge to be on the marsh side of the rock dike. At this station the dike meets the existing spoil bank and vegetation is coming up through the dike. The 1995 and 1997 surveys show the vegetated edge on the rock dike itself.

**Figure 14.** Cameron Prairie Refuge Protection (ME-09) cross section S-11A in the project area showing the survey lines, vegetation edge, and channel profile.

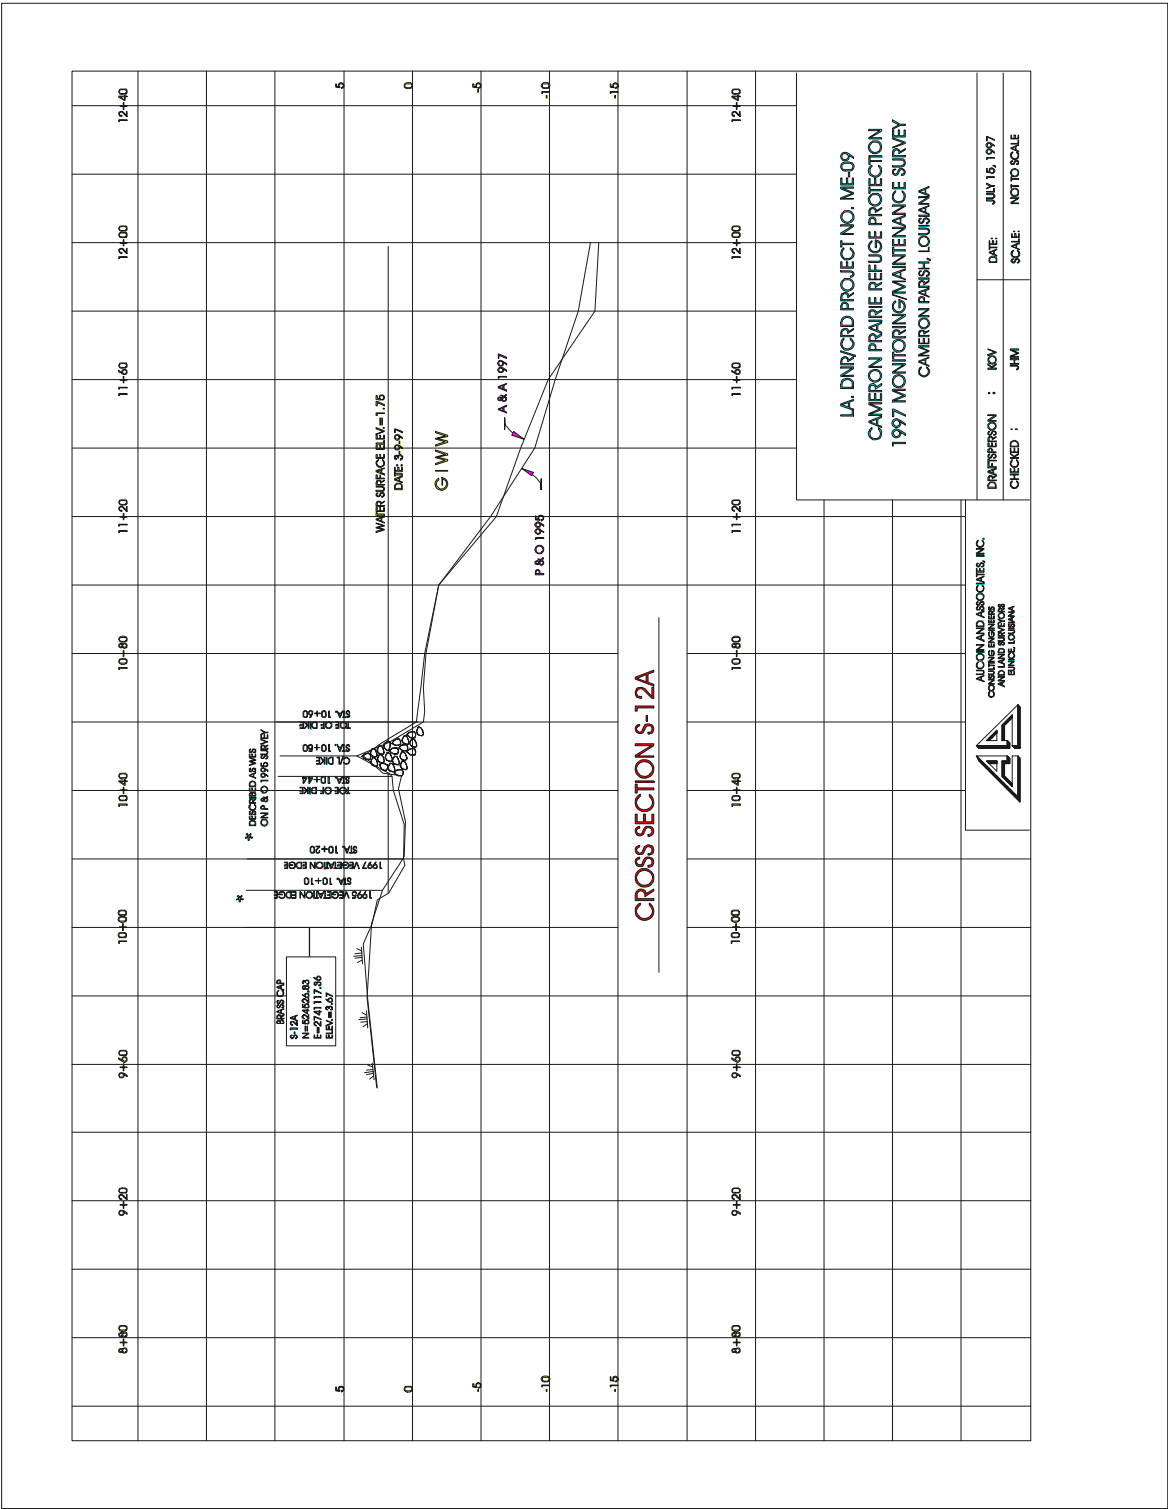
**Figure 15.** Cameron Prairie Refuge Protection (ME-09) cross section S-12A in the project area showing the survey lines, vegetation edge, and channel profile.

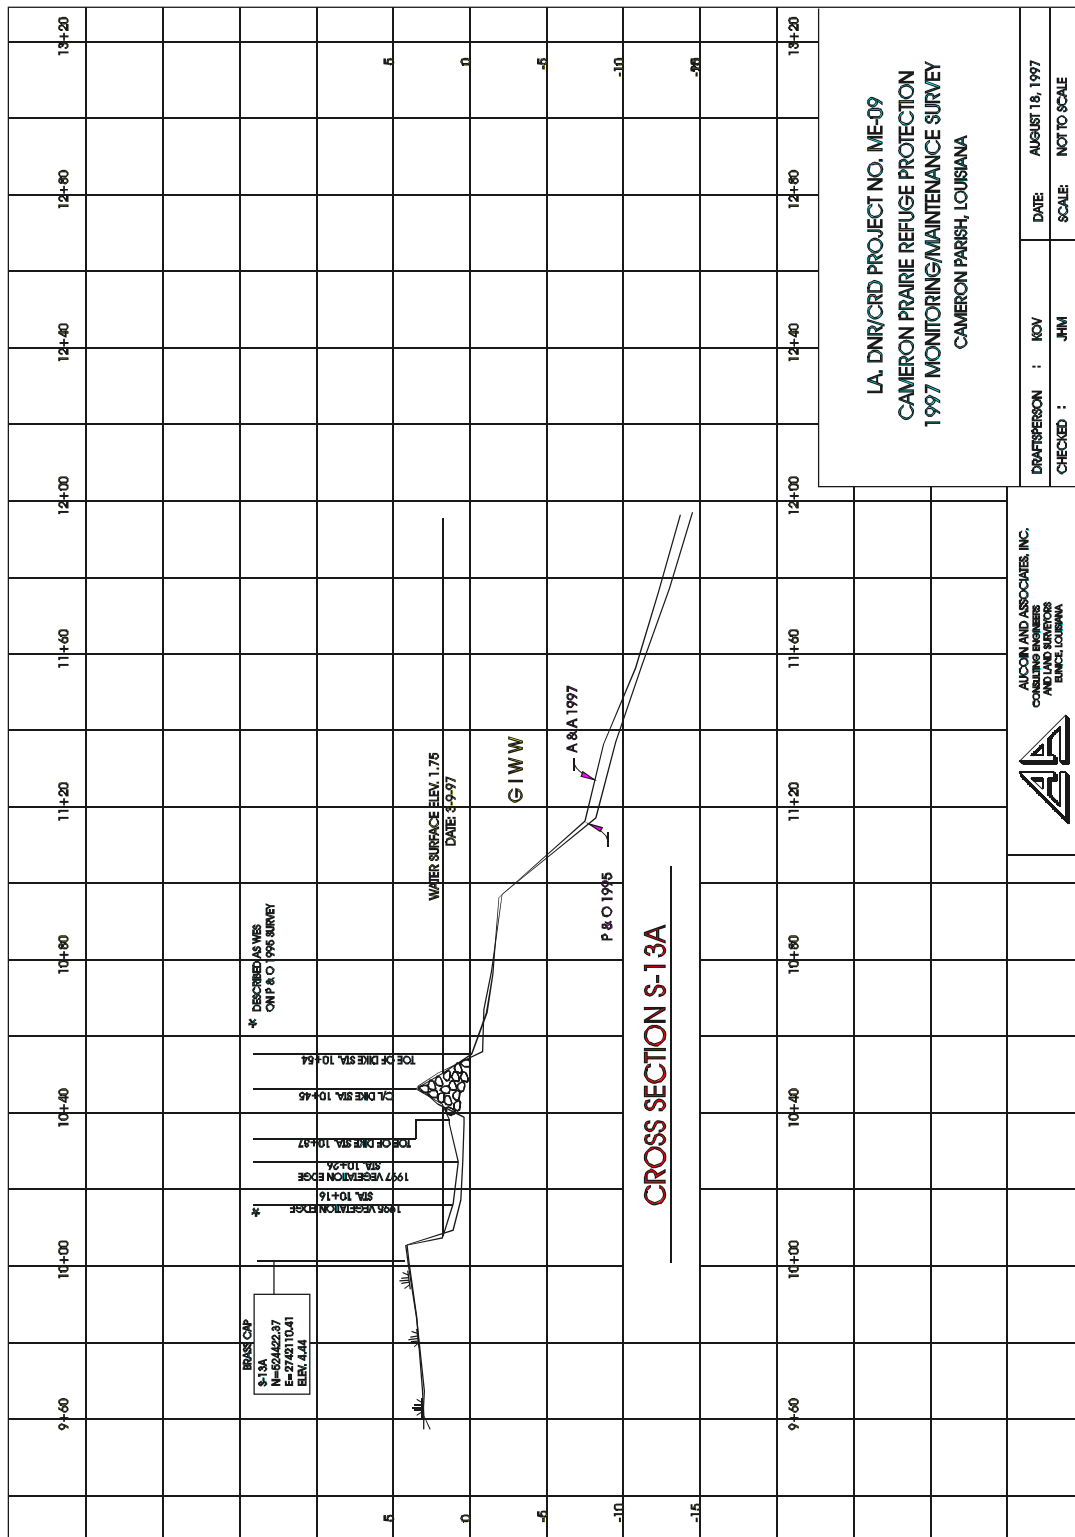
**Figure 16.** Cameron Prairie Refuge Protection (ME-09) cross section S-13A in the project area showing the survey lines, vegetation edge, and channel profile.

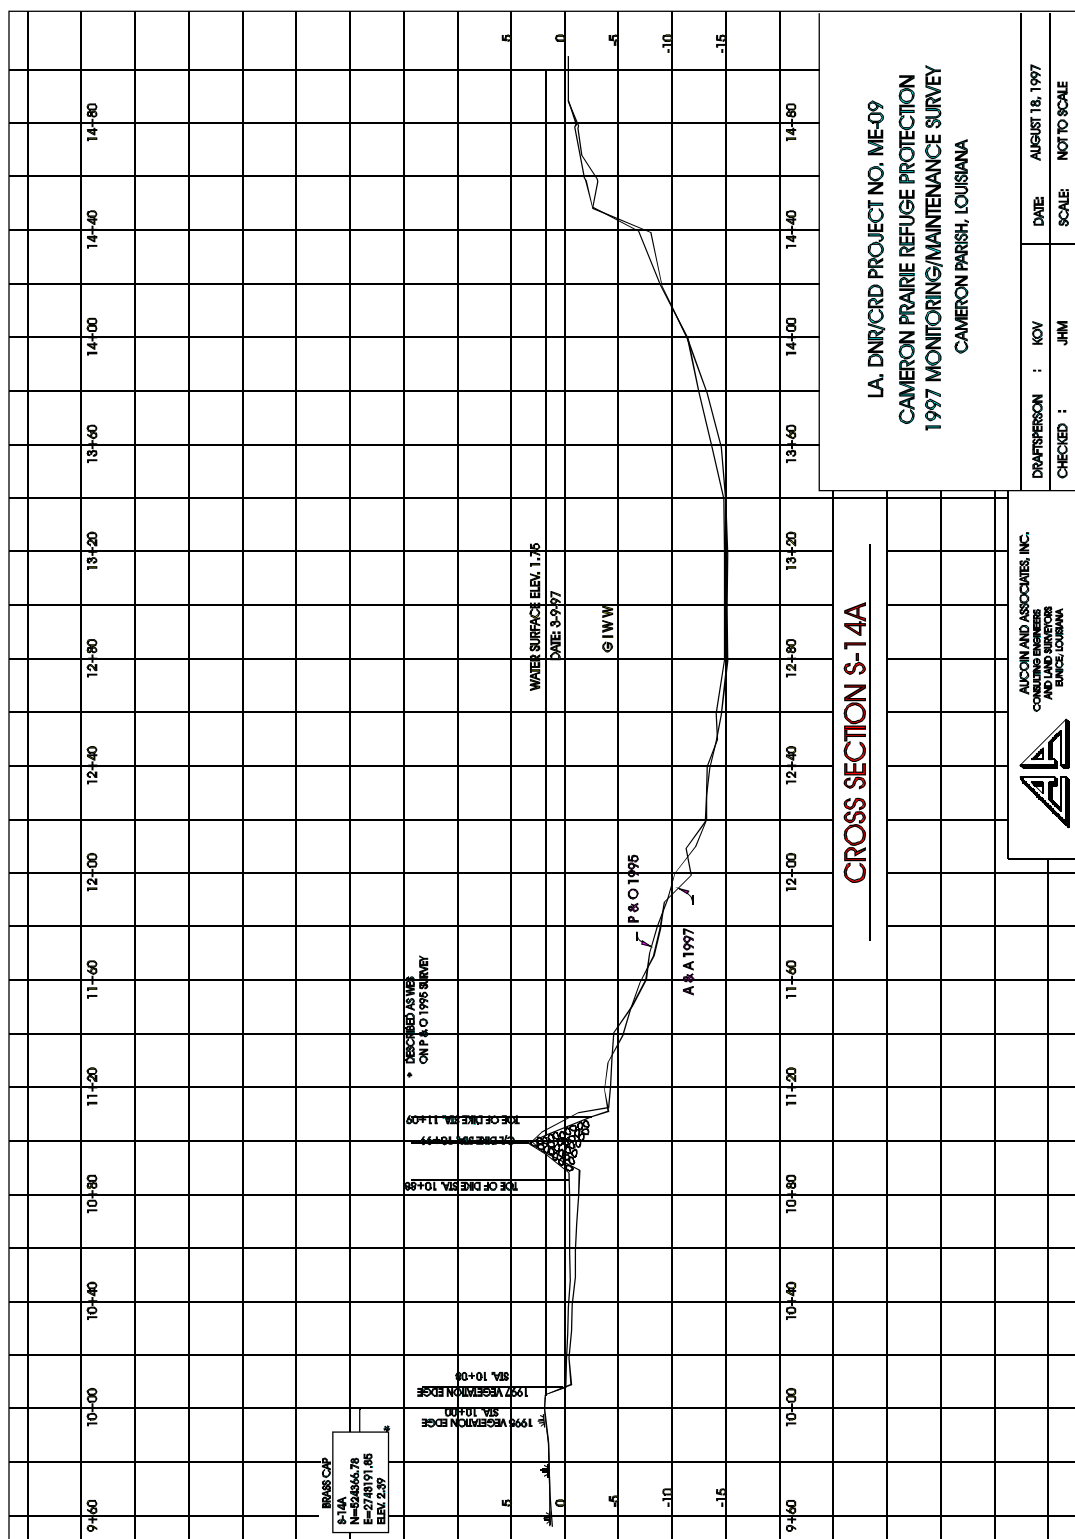
**Figure 17.** Cameron Prairie Refuge Protection (ME-09) cross section S-14A in the project area showing the survey lines, vegetation edge, and channel profile.

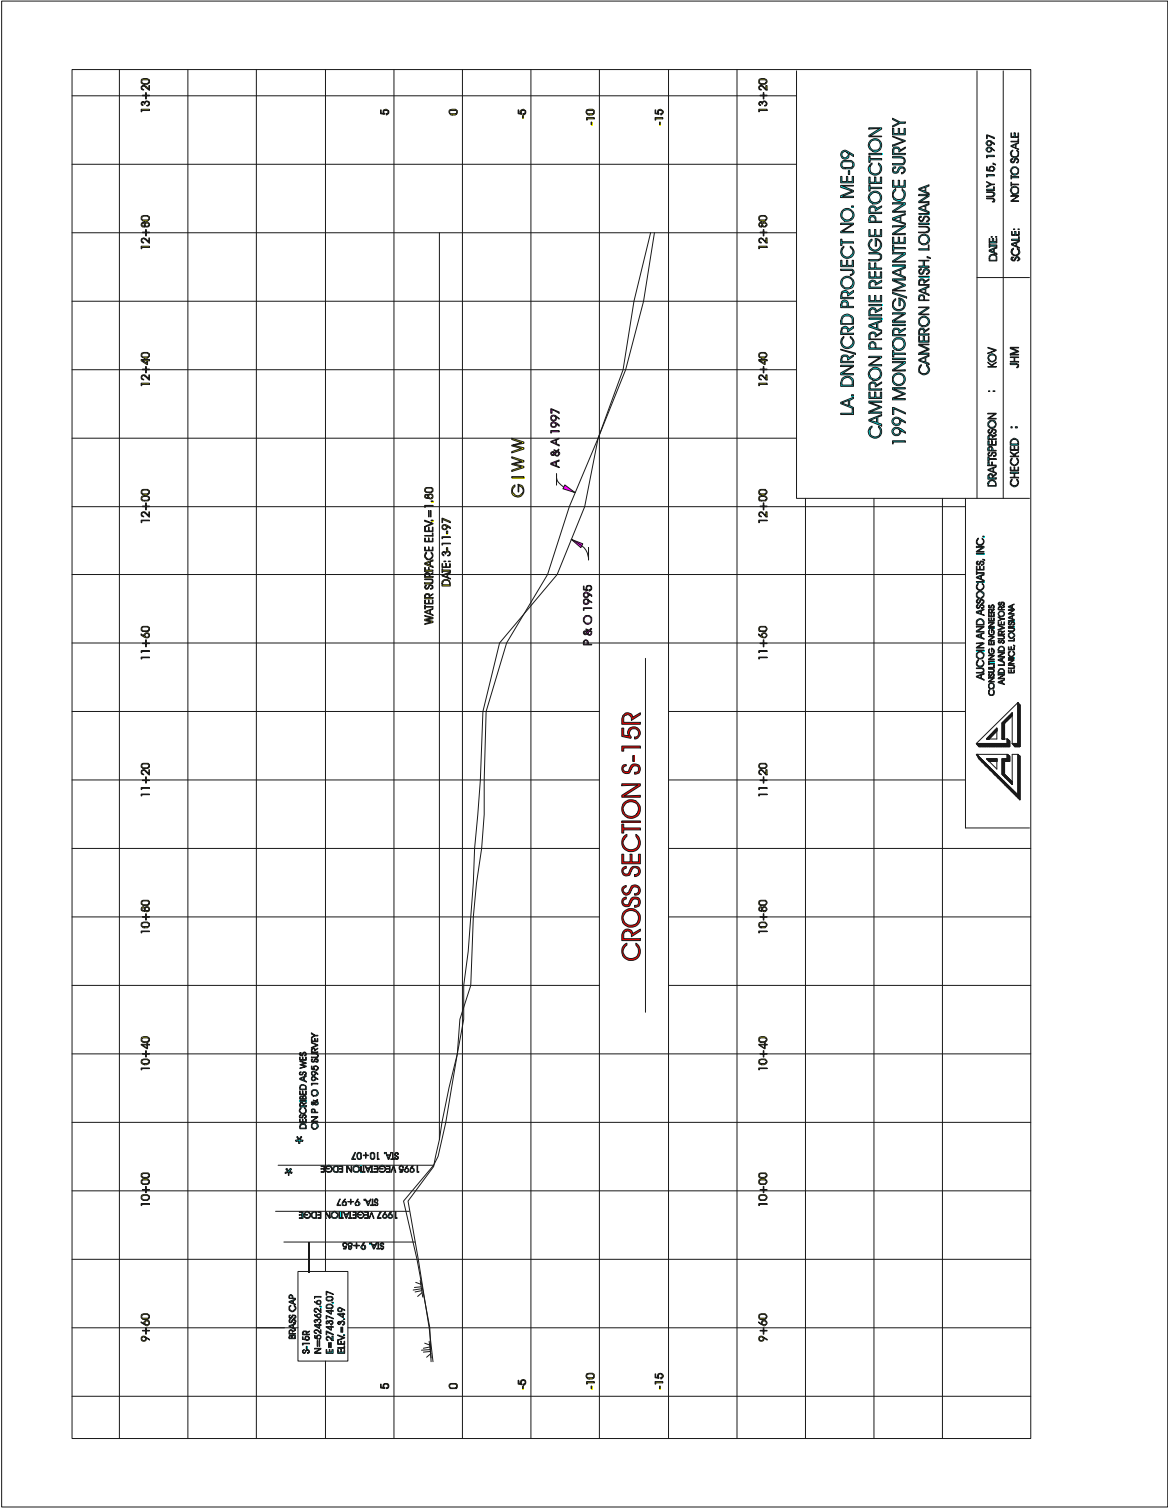
**Figure 18.** Cameron Prairie Refuge Protection (ME-09) cross section S-15R in the project area showing the survey lines, vegetation edge, and channel profile.

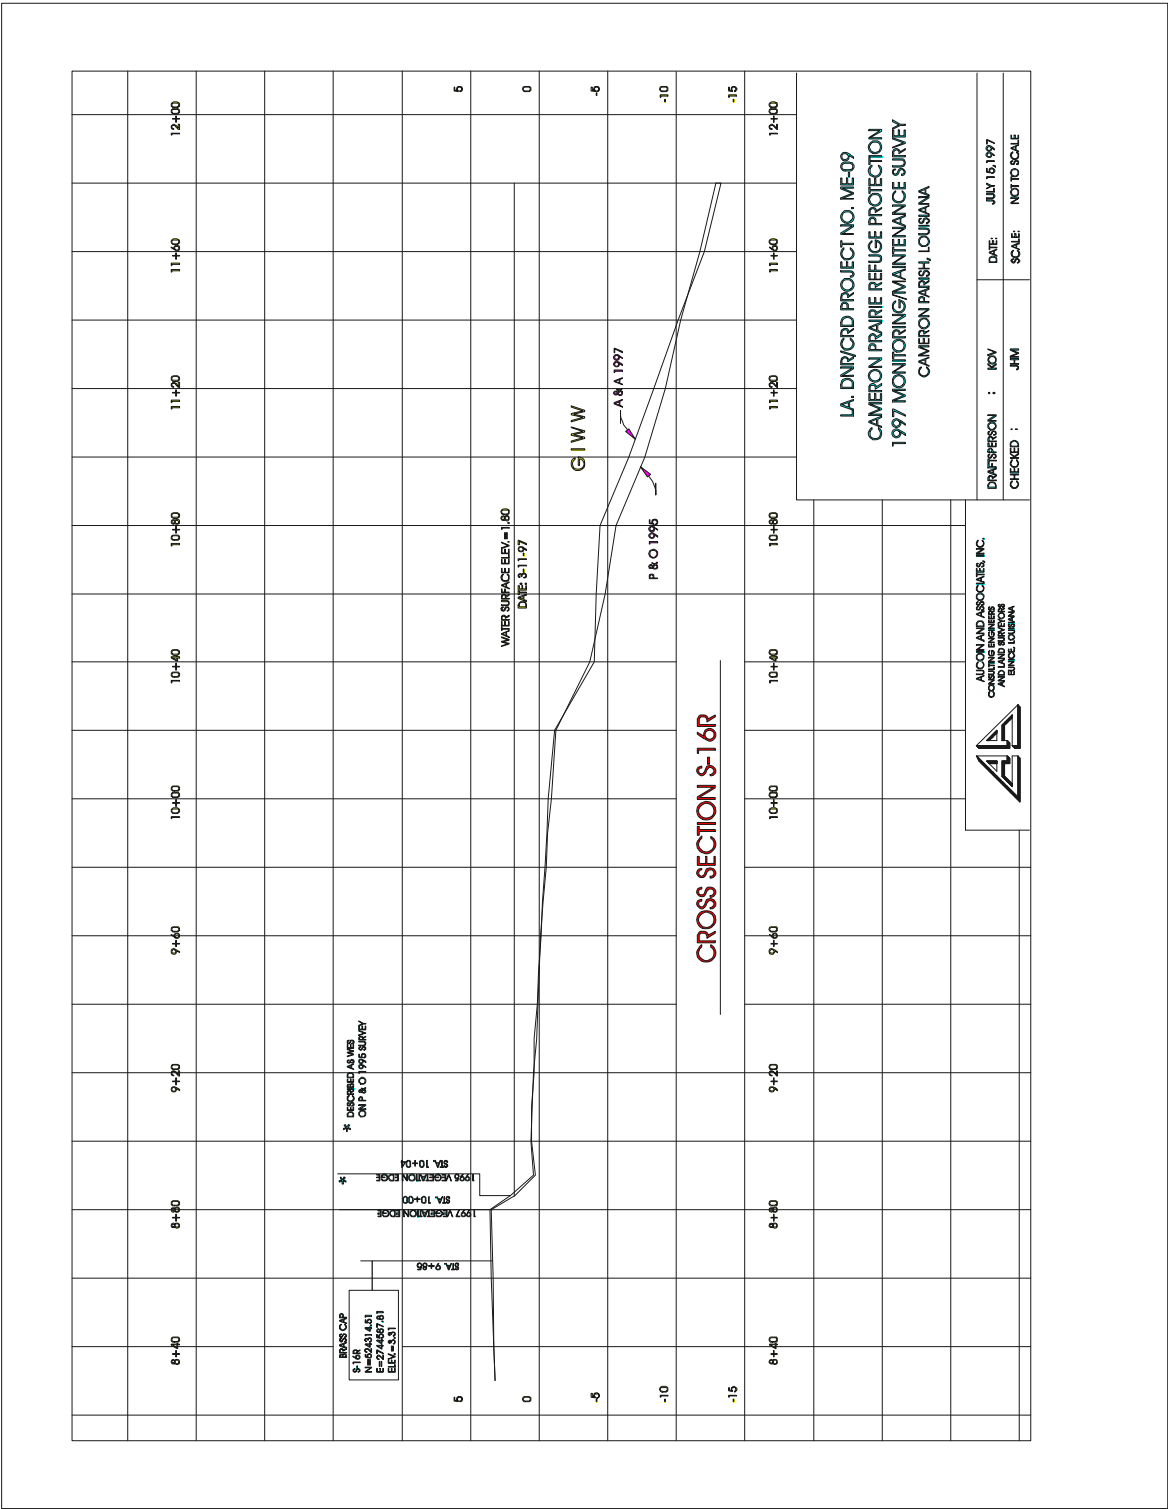
**Figure 19.** Cameron Prairie Refuge Protection (ME-09) cross section S-16R in the project area showing the survey lines, vegetation edge, and channel profile.

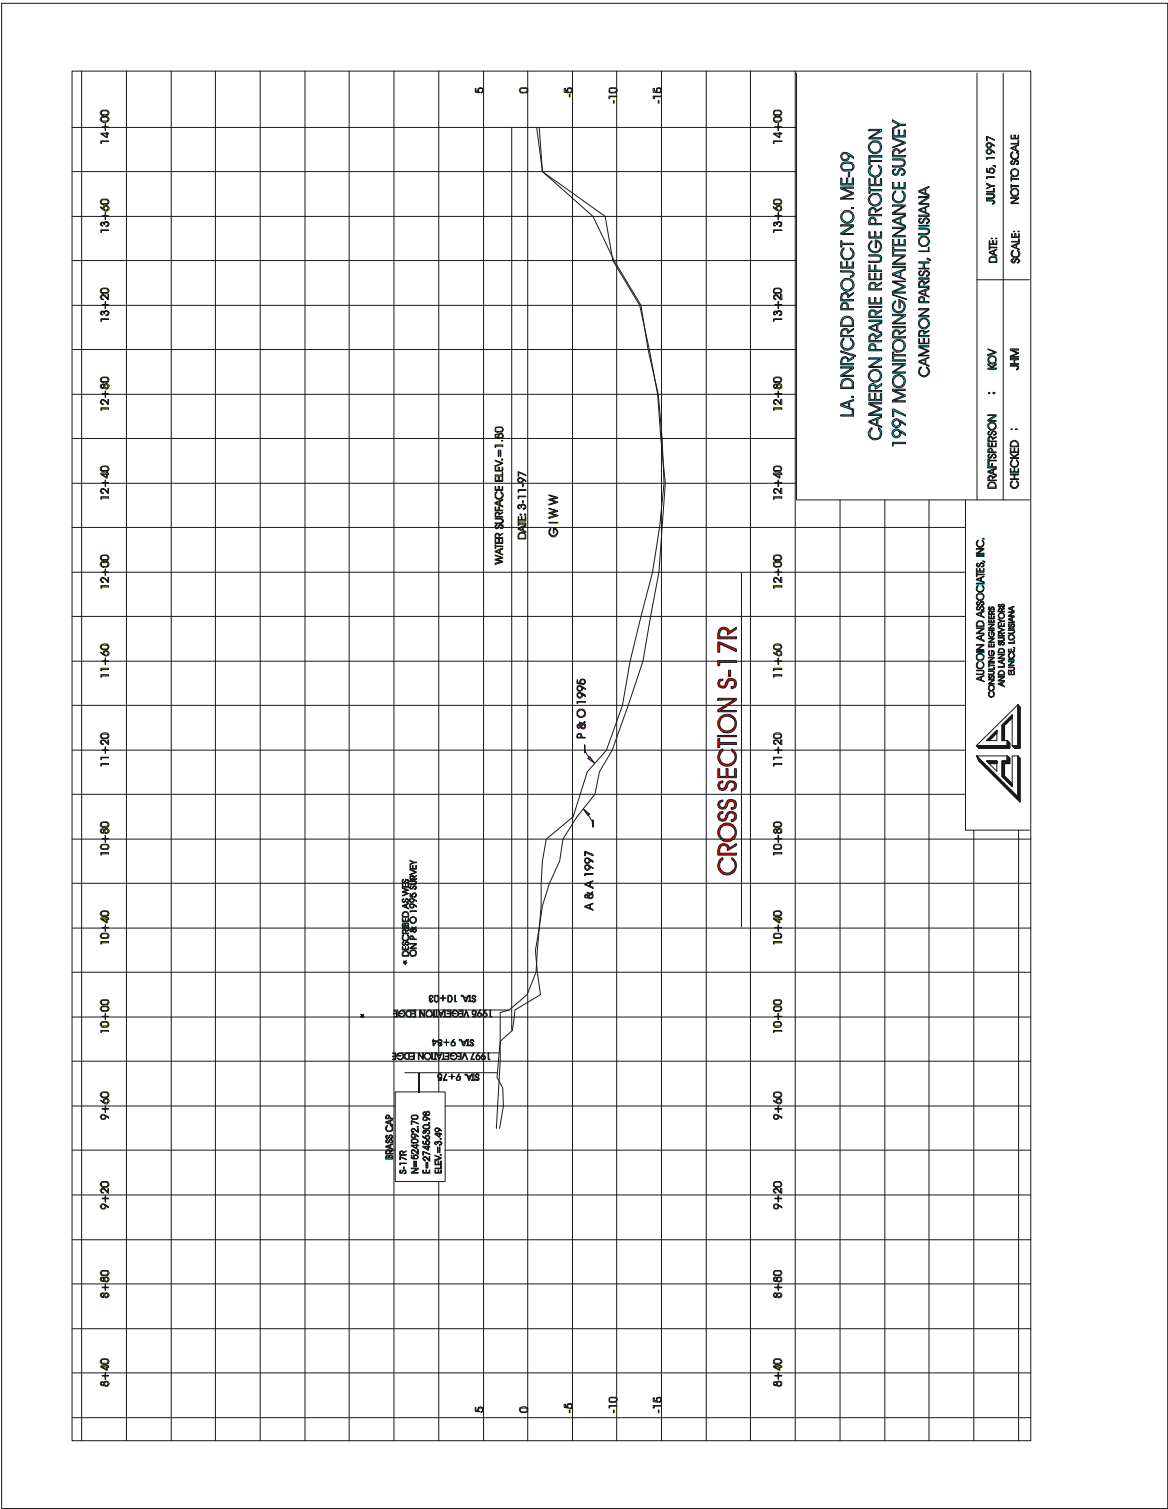
**Figure 20.** Cameron Prairie Refuge Protection (ME-09) cross section S-17R in the project area showing the survey lines, vegetation edge, and channel profile.

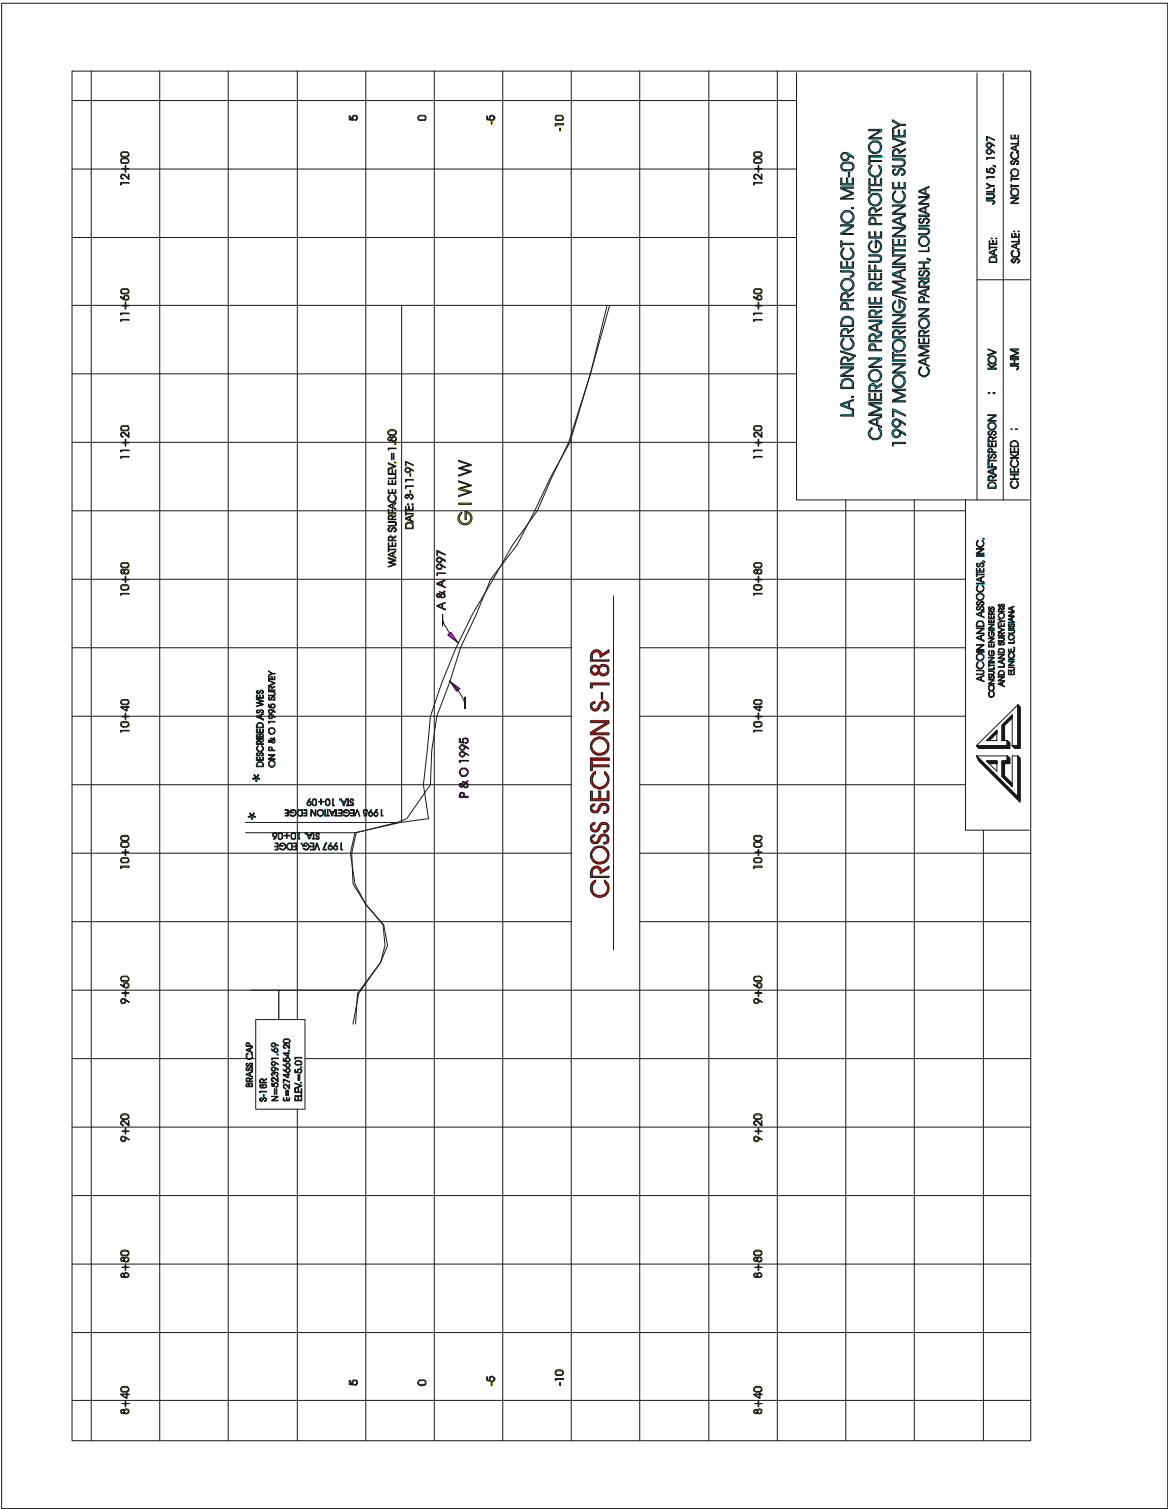
**Figure 21.** Cameron Prairie Refuge Protection (ME-09) cross section S-18R in the project area showing the survey lines, vegetation edge, and channel profile.

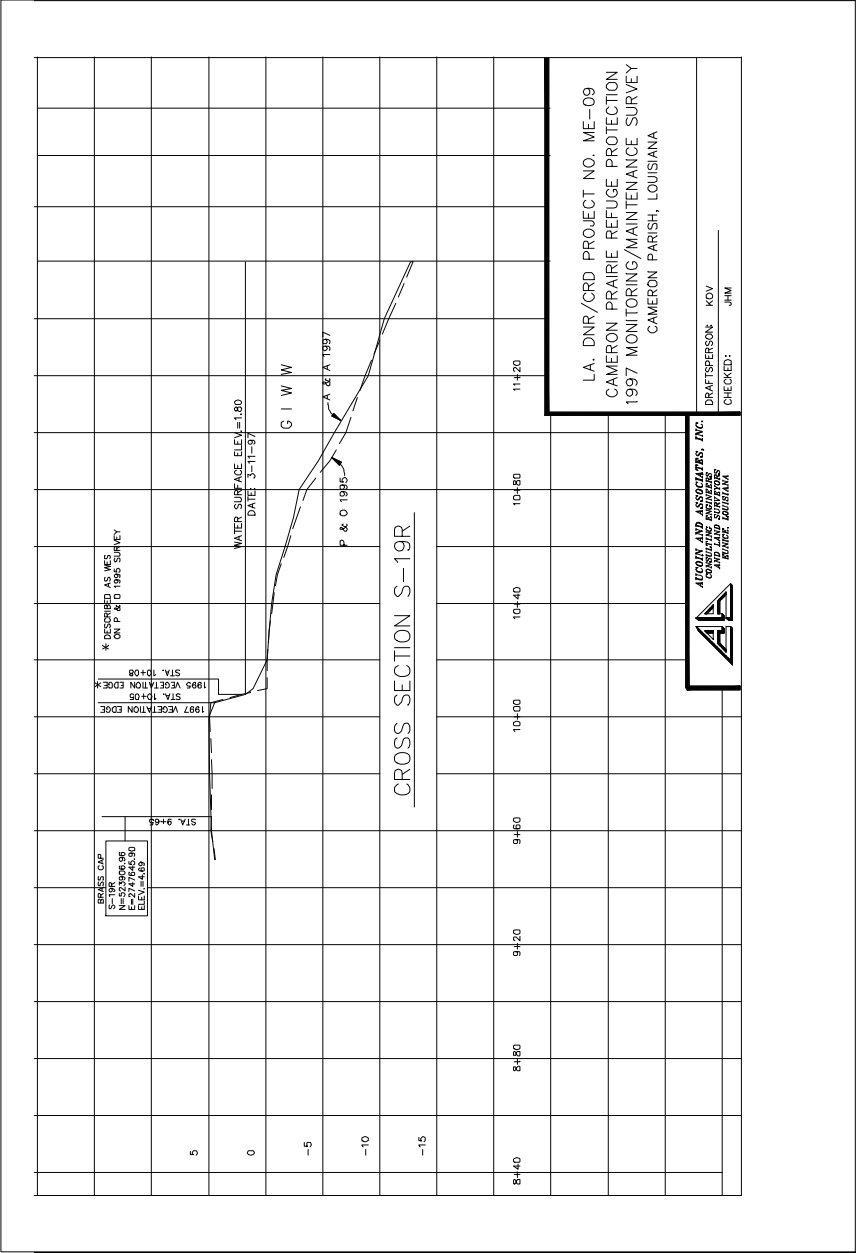
**Figure 22.** Cameron Prairie Refuge Protection (ME-09) cross section S-19R in the project area showing the survey lines, vegetation edge, and channel profile.

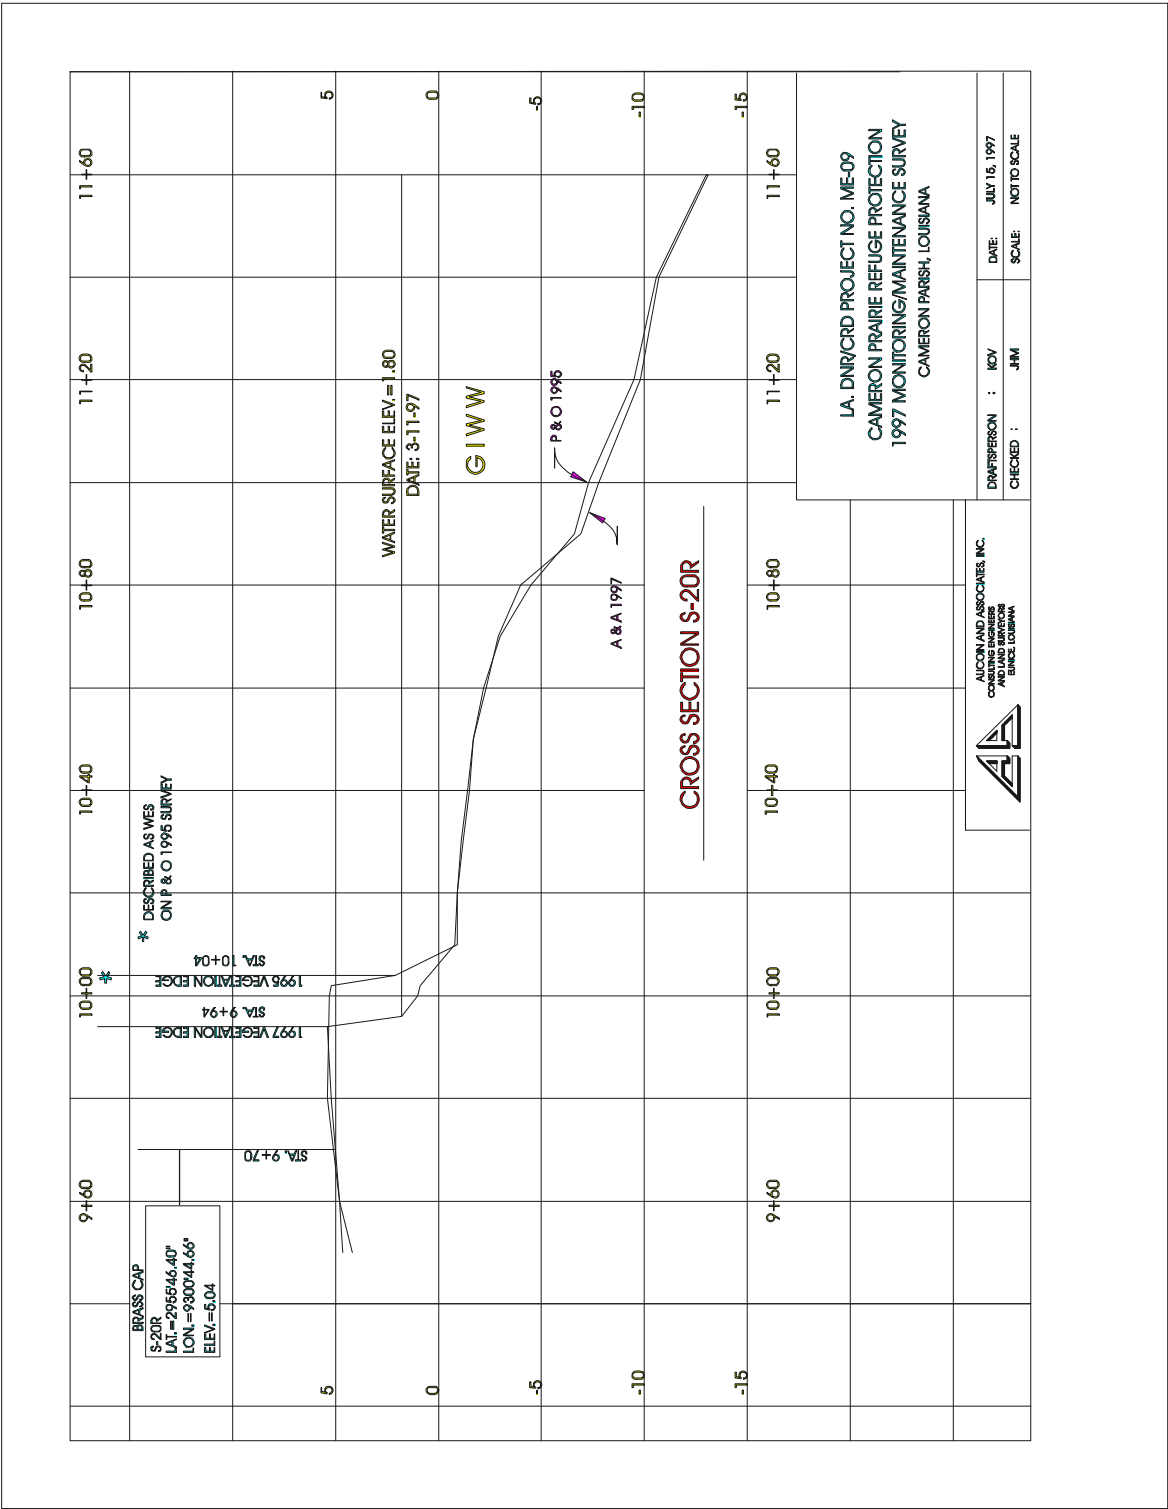
**Figure 23.** Cameron Prairie Refuge Protection (ME-09) cross section S-20R in the project area showing the survey lines, vegetation edge, and channel profile.
